## 071349 Officers Meadow Chelmsford Road Shenfield - CCTV Survey Report : 23/11/20

Name : OFFICERS MEADOW  
 Contact :  
 Location : CHELMSFORD ROAD  
 Town : SHENFIELD  
 Region : ESSEX  
 Postcode :  
 Tel :  
 Mobile :  
 Email :  
 Fax :

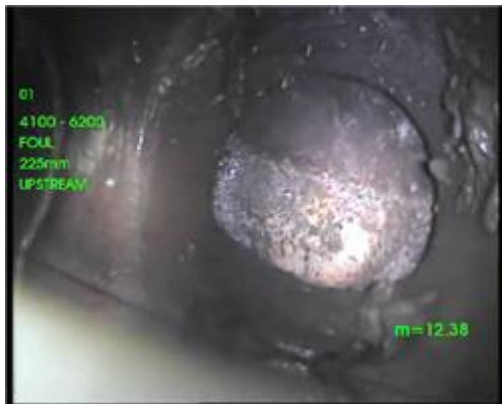
| Pos | Video Ref | Code | Description | Image |
|---|---|---|---|---|
| 11.60m | 0:00:57 | JN | Junction at 02 o'clock: 150mm Diameter<br>BLANKED OFF | Image Provided - Ref: 0_4<br> |

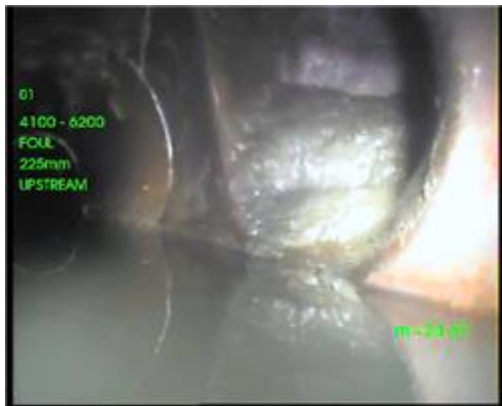
| Pos | Video Ref | Code | Description | Image |
|---|---|---|---|---|
| 24.70m | 0:02:43 | JN | Junction at 02 o'clock: 150mm Diameter<br>BLANKED OFF | Image Provided - Ref: 0_7<br> |

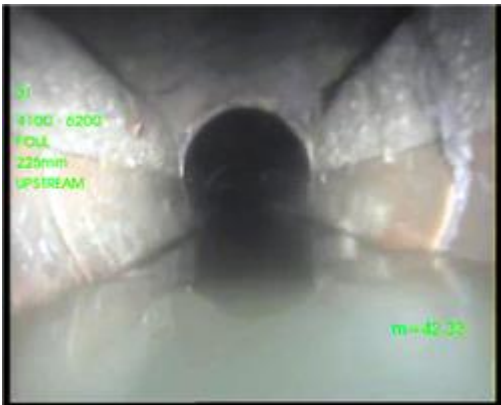
| Pos | Video Ref | Code | Description | Image |
|---|---|---|---|---|
| 42.20m | 0:04:51 | REM | General remark<br>BURIED MANHOLE 4100B | Image Provided - Ref: 0_12<br> |

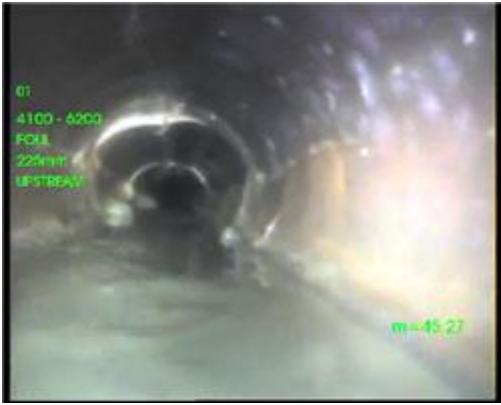
| Pos | Video Ref | Code | Description | Image |
|---|---|---|---|---|
| 45.00m | 0:05:21 | D | Deformed drain/sewer: 10% Height/Diameter - Severity 4 | Image Provided - Ref: 0_18<br> |

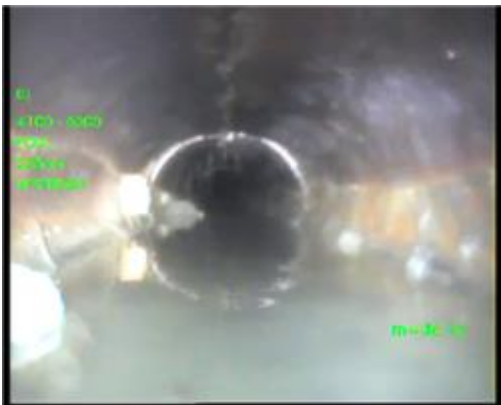
| Pos | Video Ref | Code | Description | Image |
|---|---|---|---|---|
| 46.00m | 0:05:29 | D | Deformed drain/sewer: 20% Height/Diameter - Severity 4 | Image Provided - Ref: 0_19<br> |

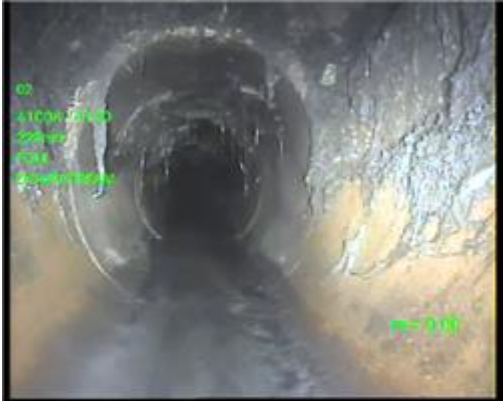
| Pos | Video Ref | Code | Description | Image |
|---|---|---|---|---|
| 00.00m | 0:00:00 | S1 DEG | Attached deposits, grease 0m - 6m from 07 o'clock to 05 o'clock: 5% Cross sectional area loss - Severity 3 | Image Provided - Ref: 1_2<br> |

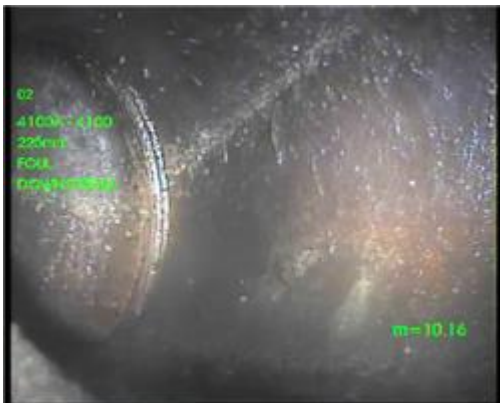
| Pos | Video Ref | Code | Description | Image |
|---|---|---|---|---|
| 10.00m | 0:01:22 | JN | Junction at 10 o'clock: 150mm Diameter<br>BLANKED OFF | Image Provided - Ref: 1_8<br> |

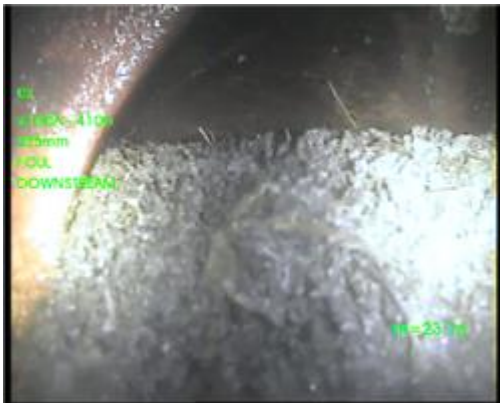
| Pos | Video Ref | Code | Description | Image |
|---|---|---|---|---|
| 23.00m | 0:02:49 | R | Roots - Severity 3<br>MASS ROOTS | Image Provided - Ref: 1_11<br> |

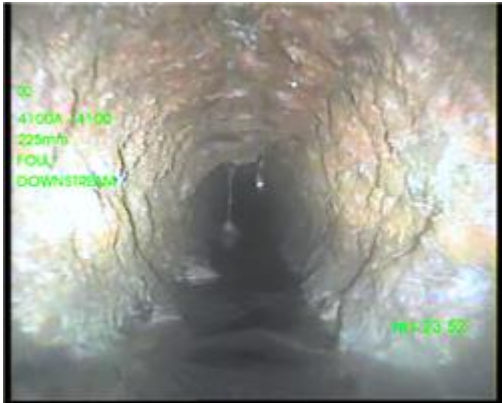
| Pos | Video Ref | Code | Description | Image |
|---|---|---|---|---|
| 23.50m | 0:03:05 | MCCI | Material of pipe changes to Cast Iron | Image Provided - Ref: 1_14<br> |

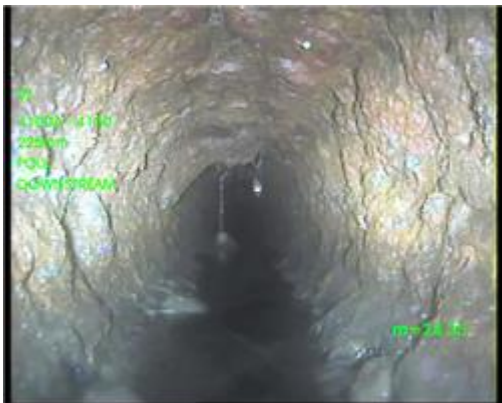
| Pos | Video Ref | Code | Description | Image |
|---|---|---|---|---|
| 23.50m | 0:03:05 | DEE | Attached deposits, encrustation from 07 o'clock to 05 o'clock: 30% Cross sectional area loss - Severity 3 | Image Provided - Ref: 1_15<br> |
| 24.35m | | SA | Survey abandoned<br>UNABLE TO PASS<br>ENCrustATION | |

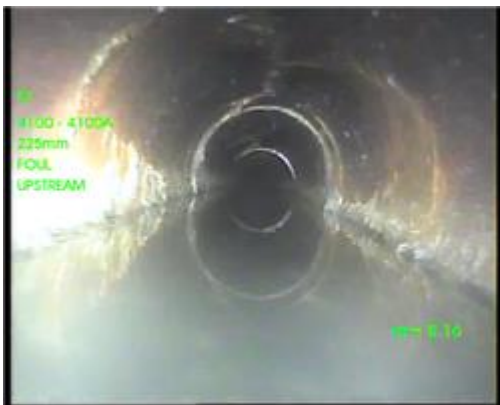
| Pos | Video Ref | Code | Description | Image |
|---|---|---|---|---|
| 00.16m | 0:00:07 | FC | Fracture circumferential from 08 o'clock to 04 o'clock - Severity 3 | Image Provided - Ref: 2_4<br> |

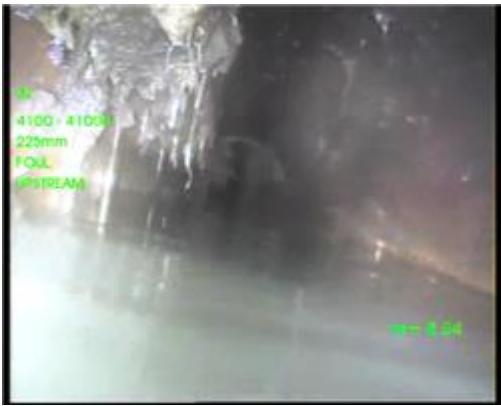
| Pos | Video Ref | Code | Description | Image |
|---|---|---|---|---|
| 08.40m | 0:01:15 | DEG | Attached deposits, grease from 09 o'clock to 11 o'clock: 20% Cross sectional area loss - Severity 3 | Image Provided - Ref: 2_13<br> |

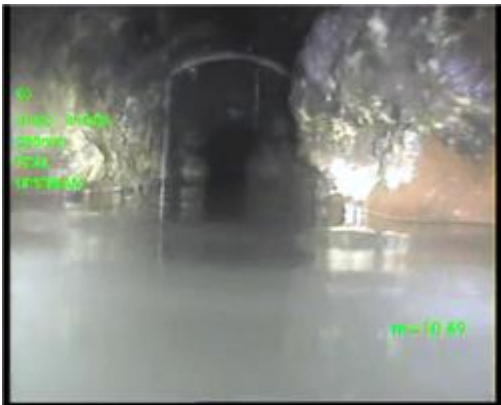
| Pos | Video Ref | Code | Description | Image |
|---|---|---|---|---|
| 10.00m | 0:01:29 | S2 DEG | Attached deposits, grease 10m - 15m from 08 o'clock to 04 o'clock: 20% Cross sectional area loss - Severity 3 | Image Provided - Ref: 2_14<br> |

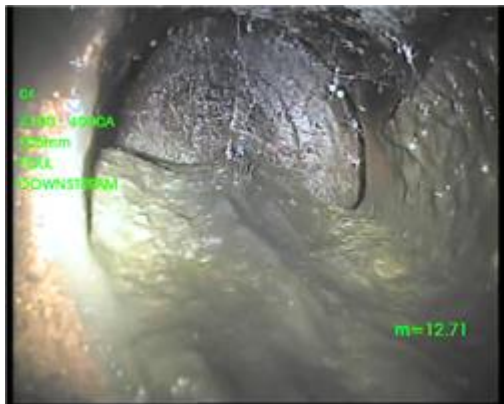
| Pos | Video Ref | Code | Description | Image |
|---|---|---|---|---|
| 12.50m | 0:01:38 | JN | Junction at 10 o'clock: 150mm Diameter | Image Provided - Ref: 3_5<br> |

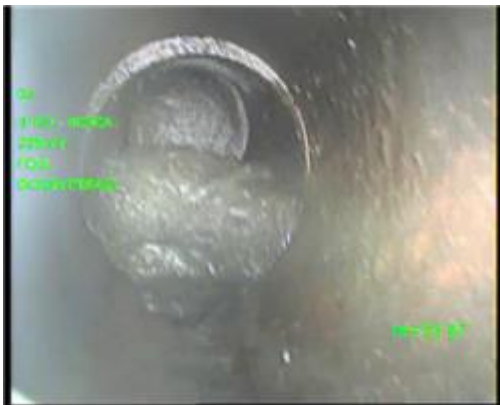
| Pos | Video Ref | Code | Description | Image |
|---|---|---|---|---|
| 25.50m | 0:03:17 | JN | Junction at 10 o'clock: 150mm Diameter<br>BLANKED OFF | Image Provided - Ref: 3_11<br> |

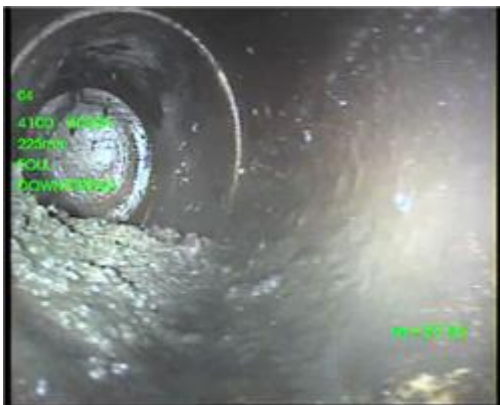
| Pos | Video Ref | Code | Description | Image |
|---|---|---|---|---|
| 39.50m | 0:05:20 | JN | Junction at 10 o'clock: 150mm Diameter | Image Provided - Ref: 3_17<br> |

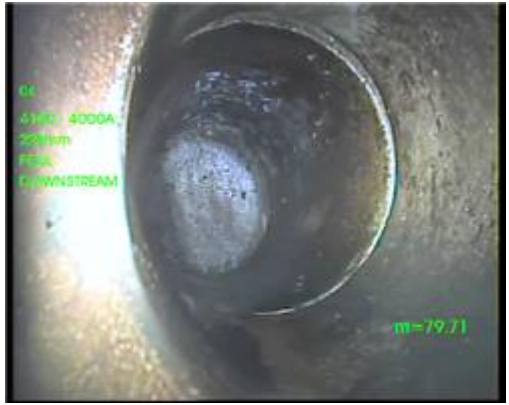
| Pos | Video Ref | Code | Description | Image |
|---|---|---|---|---|
| 79.50m | 0:10:40 | JN | Junction at 10 o'clock: 150mm Diameter<br>BLANKED OFF | Image Provided - Ref: 3_28<br> |

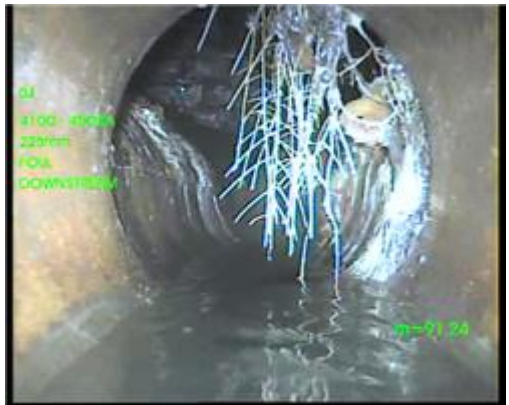
| Pos | Video Ref | Code | Description | Image |
|---|---|---|---|---|
| 91.50m | 0:11:44 | R | Roots - Severity 3<br>ROOTS IN MANHOLE | Image Provided - Ref: 3_32<br> |

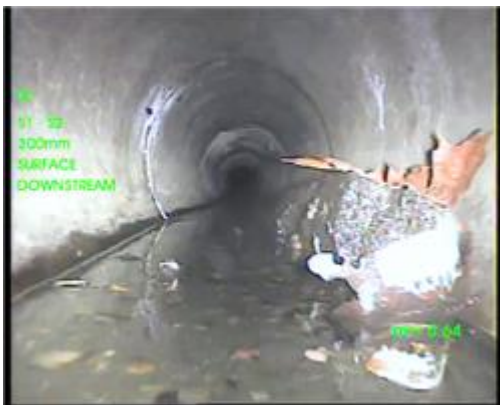
| Pos | Video Ref | Code | Description | Image |
|---|---|---|---|---|
| 00.64m | 0:00:07 | DER | Settled deposits coarse: 10%<br>Cross sectional area loss - Severity 3 | Image Provided - Ref: 5_2<br> |

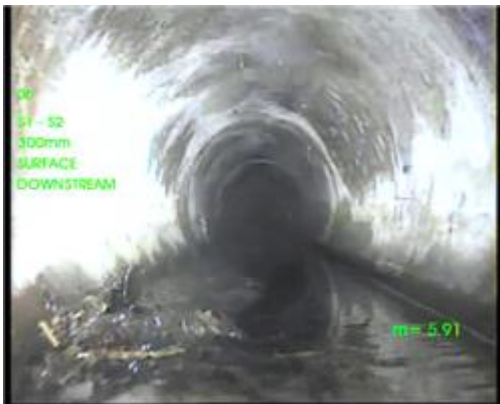
| Pos | Video Ref | Code | Description | Image |
|---|---|---|---|---|
| 05.90m | 0:00:36 | S2 DES | Settled deposits fine 5.9m - 8m: 10% Cross sectional area loss - Severity 3 | Image Provided - Ref: 5_6<br> |

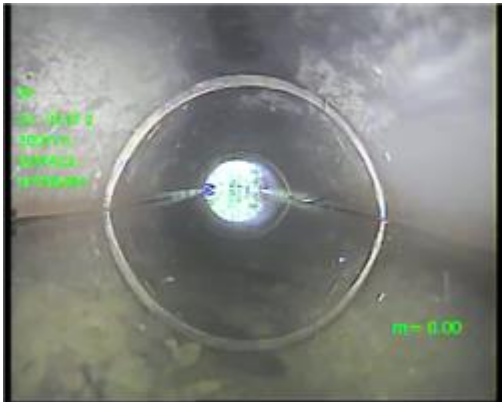
| Pos | Video Ref | Code | Description | Image |
|---|---|---|---|---|
| 00.00m | 0:00:00 | WL | Water level: 50% Height/Diameter | Image Provided - Ref: 7_1<br> |

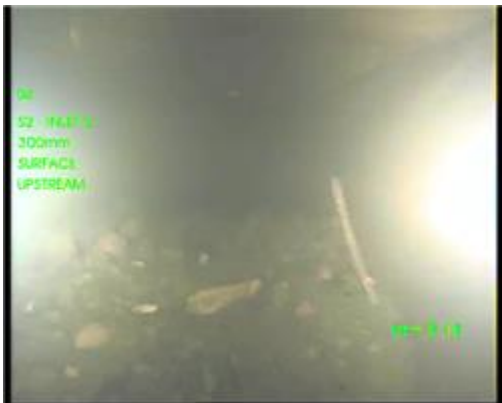
| Pos | Video Ref | Code | Description | Image |
|---|---|---|---|---|
| 00.14m | 0:00:05 | DER | Settled deposits coarse: 30% Cross sectional area loss - Severity 3 | Image Provided - Ref: 7_2<br> |
| 00.40m | | SA | Survey abandoned<br>CAMERA UNDERWATER /<br>UNABLE TO PASS DEBRIS | |

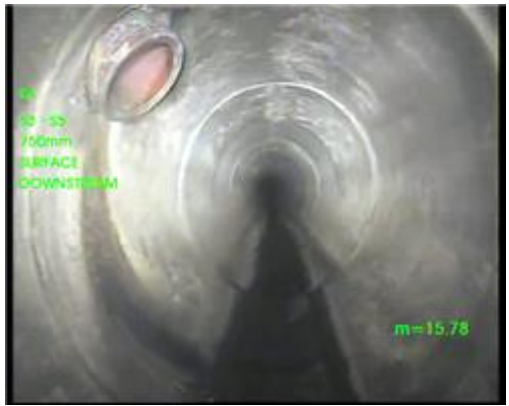
| Pos | Video Ref | Code | Description | Image |
|---|---|---|---|---|
| 15.78m | 0:00:52 | CXI | Connection intruding at 11 o'clock: 10% Intrusion : 150mm Diameter - Severity 3 | <p>Image Provided - Ref: 9_3</p> |

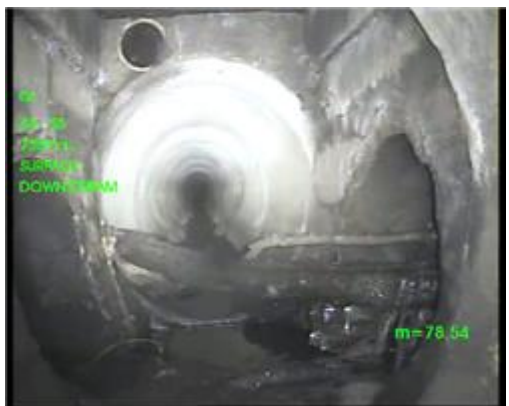
| Pos | Video Ref | Code | Description | Image |
|---|---|---|---|---|
| 78.54m | 0:03:48 | REM | General remark DEBRIS IN MANHOLE | <p>Image Provided - Ref: 9_4</p> |

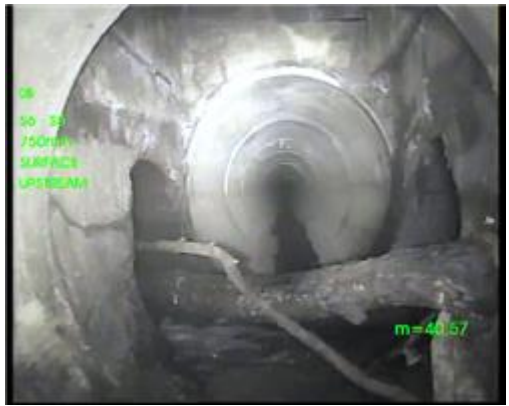
| Pos | Video Ref | Code | Description | Image |
|---|---|---|---|---|
| 40.57m | 0:02:03 | REM | General remark<br>DEBRIS IN MANHOLE | <p>Image Provided - Ref: 10_3</p> |

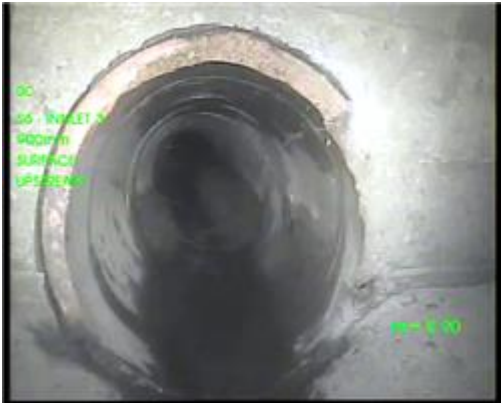
| Pos | Video Ref | Code | Description | Image |
|---|---|---|---|---|
| 00.75m | 0:00:12 | CN | Connection other than junction at 09 o'clock: 300mm Diameter | Image Provided - Ref: 11_2<br> |

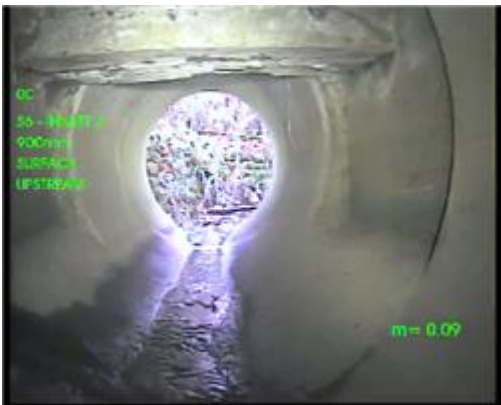
| Pos | Video Ref | Code | Description | Image |
|---|---|---|---|---|
| 00.75m | 0:00:07 | REM | General remark OBSTRUCTION AT HIGH LEVEL / POSSIBLE CHAMBER CONSTRUCTION | Image Provided - Ref: 11_3<br> |

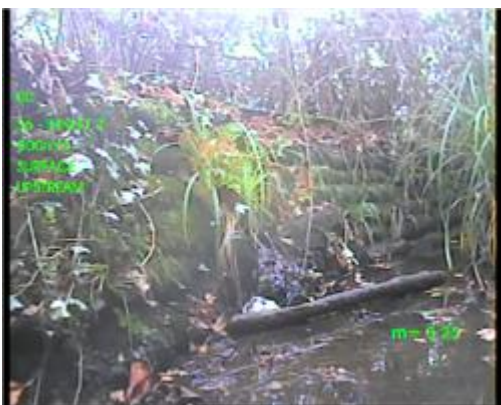
| Pos | Video Ref | Code | Description | Image |
|---|---|---|---|---|
| 03.25m | | WRF | Finish node type, major connection without manhole INLET 3 | Image Provided - Ref: 11_9999<br> |

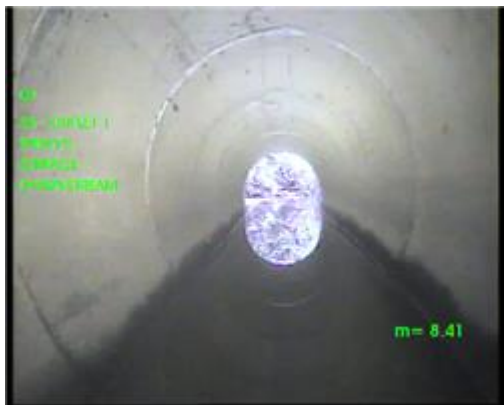
| Pos | Video Ref | Code | Description | Image |
|---|---|---|---|---|
| 08.00m | 0:00:26 | WL | Water level: 20% Height/Diameter | <p>Image Provided - Ref: 12_3</p> |

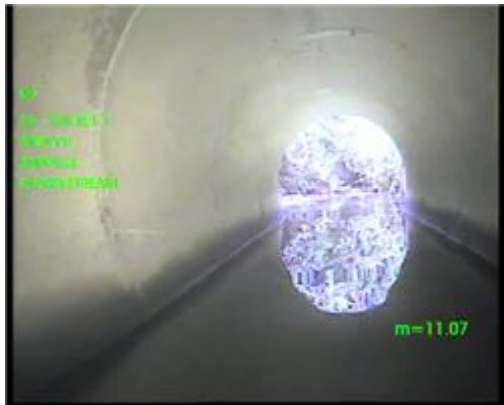
| Pos | Video Ref | Code | Description | Image |
|---|---|---|---|---|
| 11.00m | 0:00:34 | WL | Water level: 30% Height/Diameter | <p>Image Provided - Ref: 12_4</p> |
