# CCTV REPORT

| <b>DATE</b> | 23/11/2020 |

Site  
**OFFICERS MEADOW  
CHELMSFORD ROAD  
SHENFIELD  
ESSEX**

## 071349 Officers Meadow Chelmsford Road Shenfield - CCTV Survey Report : 23/11/20

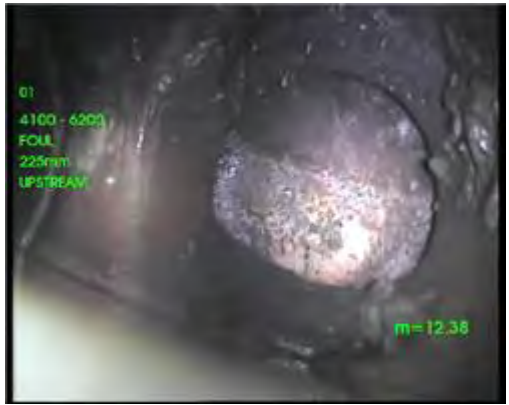
| Pos | Video Ref | Code | Description | Image |
|---|---|---|--|---|
| 11.60m | 0:00:57 | JN | Junction at 02 o'clock: 150mm Diameter<br>BLANKED OFF | Image Provided - Ref: 0_4<br> |

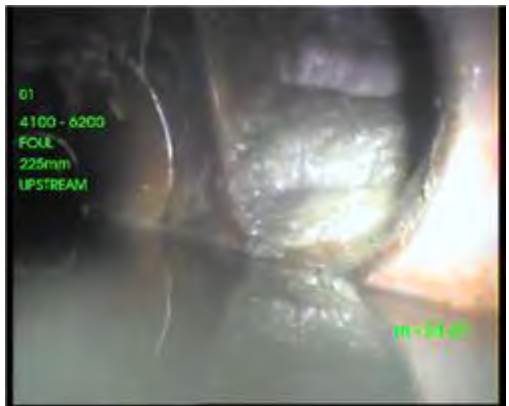
| Pos | Video Ref | Code | Description | Image |
|---|---|---|--|---|
| 24.70m | 0:02:43 | JN | Junction at 02 o'clock: 150mm Diameter<br>BLANKED OFF | Image Provided - Ref: 0_7<br> |

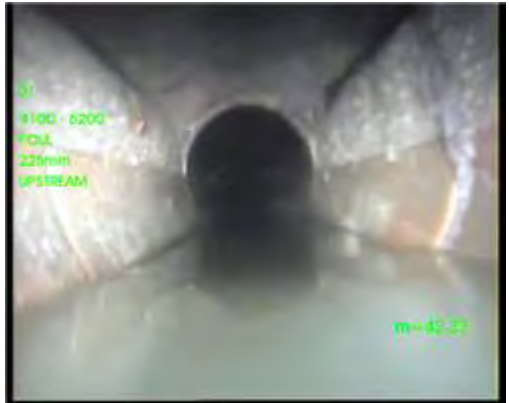
| Pos | Video Ref | Code | Description | Image |
|---|---|---|---|---|
| 42.20m | 0:04:51 | REM | General remark<br>BURIED MANHOLE 4100B | Image Provided - Ref: 0_12<br> |

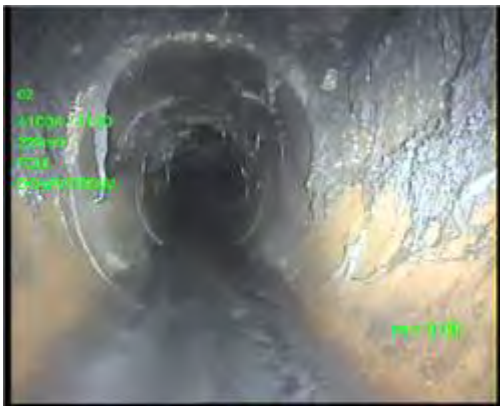
| Pos | Video Ref | Code | Description | Image |
|---|---|---|---|---|
| 00.00m | 0:00:00 | S1 DEG | Attached deposits, grease 0m - 6m from 07 o'clock to 05 o'clock: 5% Cross sectional area loss - Severity 3 | Image Provided - Ref: 1_2<br> |

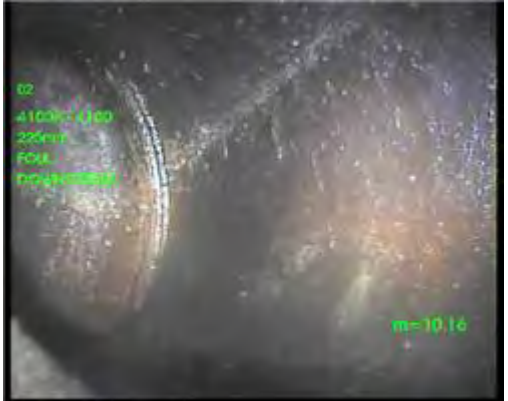
| Pos | Video Ref | Code | Description | Image |
|---|---|---|--|---|
| 10.00m | 0:01:22 | JN | Junction at 10 o'clock: 150mm Diameter<br>BLANKED OFF | Image Provided - Ref: 1_8<br> |

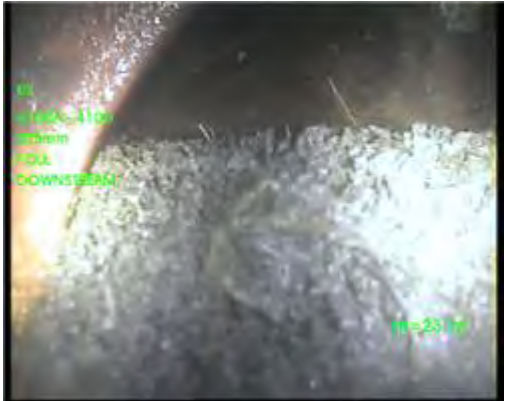
| Pos | Video Ref | Code | Description | Image |
|---|---|---|--|---|
| 23.00m | 0:02:49 | R | Roots - Severity 3<br>MASS ROOTS | Image Provided - Ref: 1_11<br> |

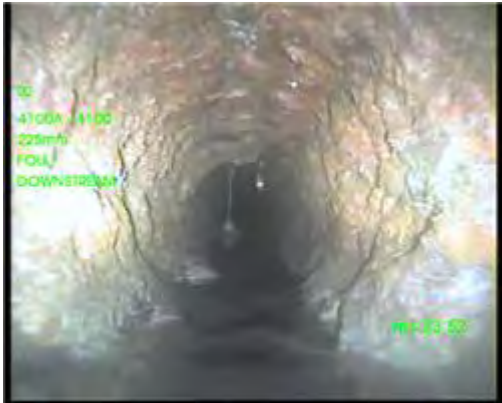
| Pos | Video Ref | Code | Description | Image |
|---|---|---|---|---|
| 23.50m | 0:03:05 | MCCI | Material of pipe changes to Cast Iron | Image Provided - Ref: 1_14<br> |

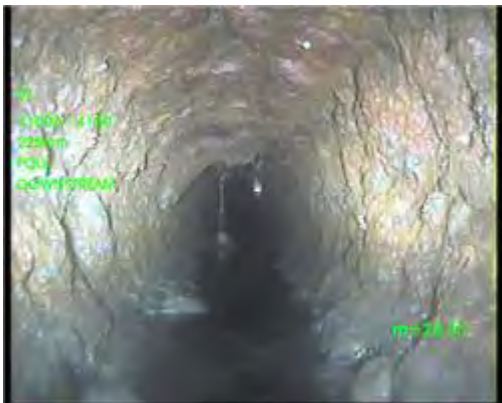
| Pos | Video Ref | Code | Description | Image |
|---|---|---|---|---|
| 23.50m | 0:03:05 | DEE | Attached deposits, encrustation from 07 o'clock to 05 o'clock: 30% Cross sectional area loss - Severity 3 | Image Provided - Ref: 1_15<br> |
| 24.35m | | SA | Survey abandoned<br>UNABLE TO PASS<br>ENCrustATION | |

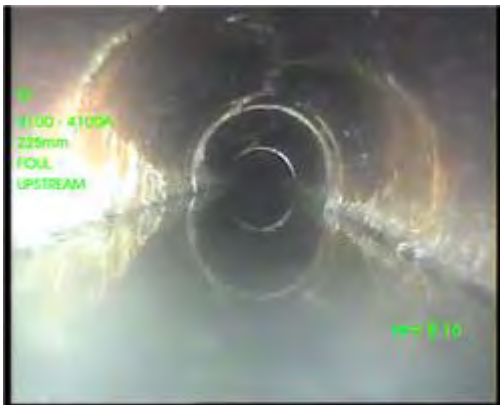
| Pos | Video Ref | Code | Description | Image |
|---|---|---|---|--|
| 00.16m | 0:00:07 | FC | Fracture circumferential from 08 o'clock to 04 o'clock - Severity 3 | Image Provided - Ref: 2_4<br> |

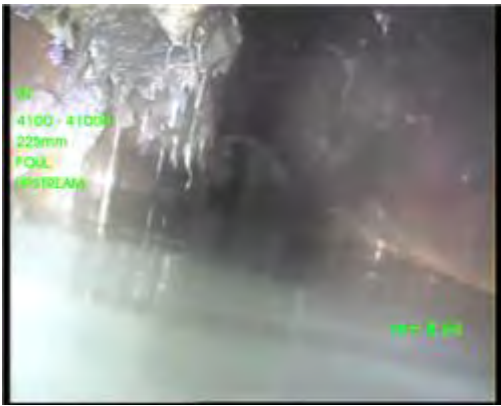
| Pos | Video Ref | Code | Description | Image |
|---|---|---|---|--|
| 08.40m | 0:01:15 | DEG | Attached deposits, grease from 09 o'clock to 11 o'clock: 20% Cross sectional area loss - Severity 3 | Image Provided - Ref: 2_13<br> |

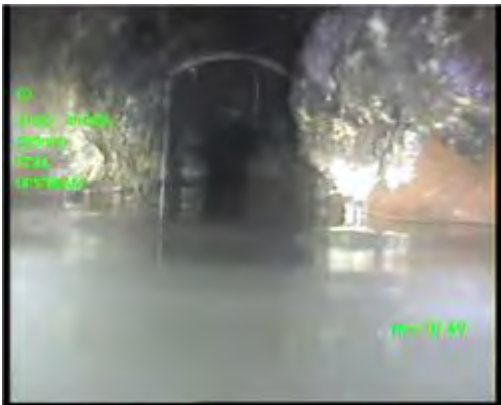
| Pos | Video Ref | Code | Description | Image |
|---|---|---|---|--|
| 10.00m | 0:01:29 | S2 DEG | Attached deposits, grease 10m - 15m from 08 o'clock to 04 o'clock: 20% Cross sectional area loss - Severity 3 | Image Provided - Ref: 2_14<br> |

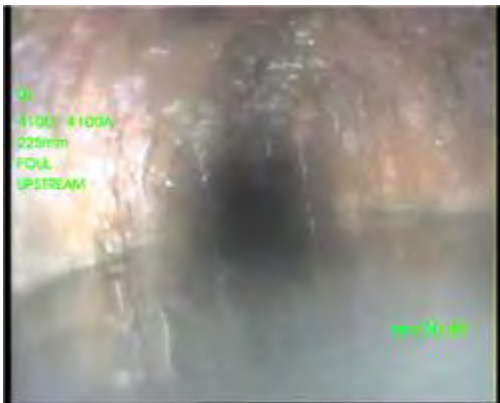
| Pos | Video Ref | Code | Description | Image |
|---|---|---|---|--|
| 20.00m | 0:02:16 | MCCI | Material of pipe changes to Cast Iron | Image Provided - Ref: 2_17<br> |

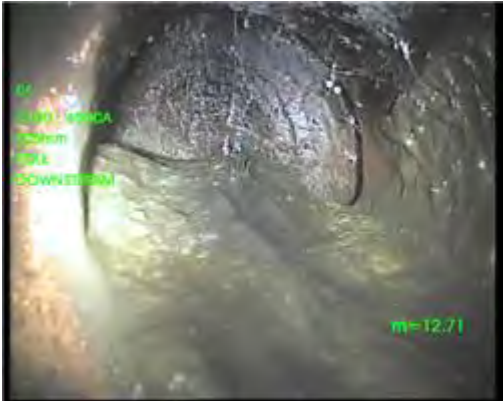
| Pos | Video Ref | Code | Description | Image |
|---|---|---|--|--|
| 12.50m | 0:01:38 | JN | Junction at 10 o'clock: 150mm Diameter | Image Provided - Ref: 3_5<br> |

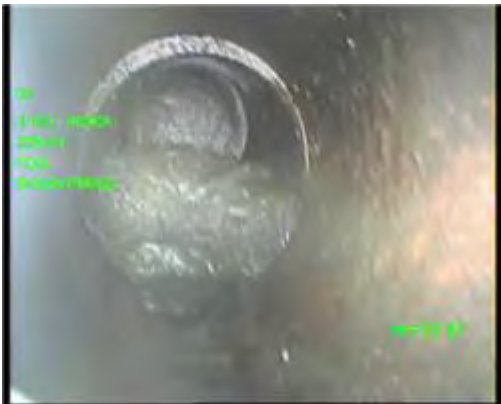
| Pos | Video Ref | Code | Description | Image |
|---|---|---|---|--|
| 25.50m | 0:03:17 | JN | Junction at 10 o'clock: 150mm Diameter<br>BLANKED OFF | Image Provided - Ref: 3_11<br> |

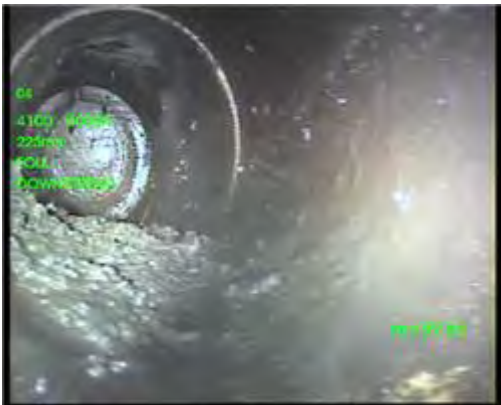
| Pos | Video Ref | Code | Description | Image |
|---|---|---|---|--|
| 39.50m | 0:05:20 | JN | Junction at 10 o'clock: 150mm Diameter | Image Provided - Ref: 3_17<br> |

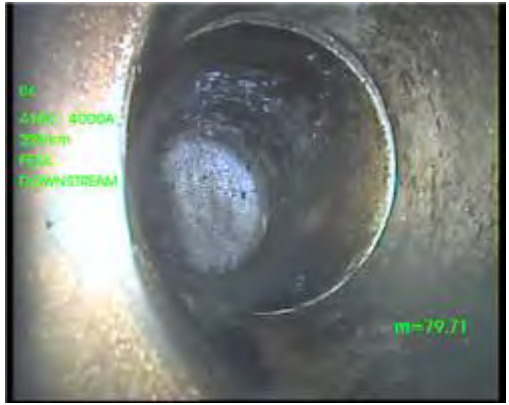
| Pos | Video Ref | Code | Description | Image |
|---|---|---|--|--|
| 79.50m | 0:10:40 | JN | Junction at 10 o'clock: 150mm Diameter<br>BLANKED OFF | Image Provided - Ref: 3_28<br> |

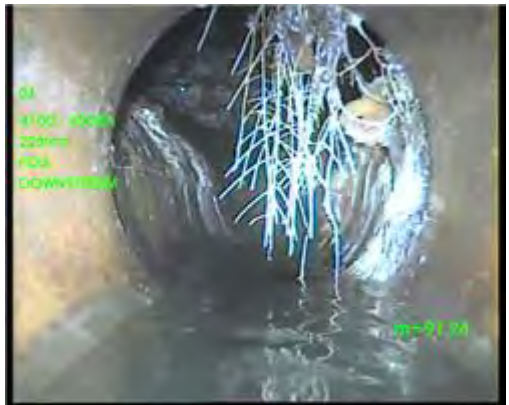
| Pos | Video Ref | Code | Description | Image |
|---|---|---|--|--|
| 91.50m | 0:11:44 | R | Roots - Severity 3<br>ROOTS IN MANHOLE | Image Provided - Ref: 3_32<br> |

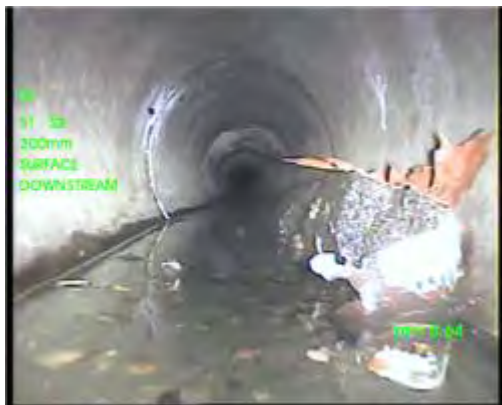
| Pos | Video Ref | Code | Description | Image |
|---|---|---|--|---|
| 00.64m | 0:00:07 | DER | Settled deposits coarse: 10%<br>Cross sectional area loss -<br>Severity 3 | Image Provided - Ref: 5_2<br> |

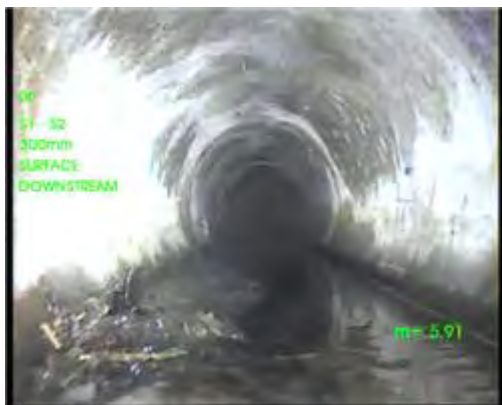
| Pos | Video Ref | Code | Description | Image |
|---|---|---|--|---|
| 05.90m | 0:00:36 | S2 DES | Settled deposits fine 5.9m -<br>8m: 10% Cross sectional area<br>loss - Severity 3 | Image Provided - Ref: 5_6<br> |

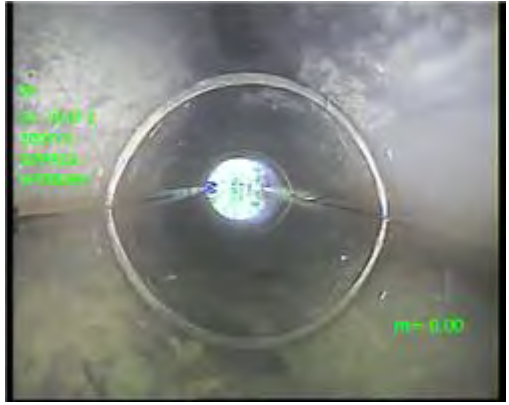
| Pos | Video Ref | Code | Description | Image |
|---|---|---|---|---|
| 00.00m | 0:00:00 | WL | Water level: 50% Height/Diameter | Image Provided - Ref: 7_1<br> |

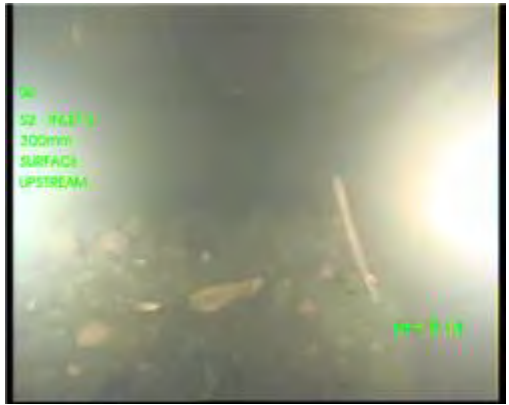
| Pos | Video Ref | Code | Description | Image |
|---|---|---|---|---|
| 00.14m | 0:00:05 | DER | Settled deposits coarse: 30% Cross sectional area loss - Severity 3 | Image Provided - Ref: 7_2<br> |
| 00.40m | | SA | Survey abandoned<br>CAMERA UNDERWATER /<br>UNABLE TO PASS DEBRIS | |

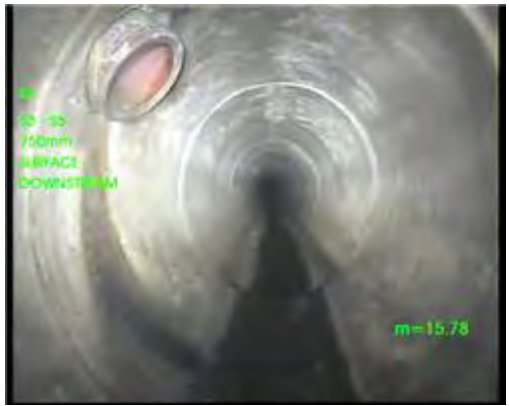
| Pos | Video Ref | Code | Description | Image |
|---|---|---|---|---|
| 15.78m | 0:00:52 | CXI | Connection intruding at 11 o'clock: 10% Intrusion : 150mm Diameter - Severity 3 | <p>Image Provided - Ref: 9_3</p> |

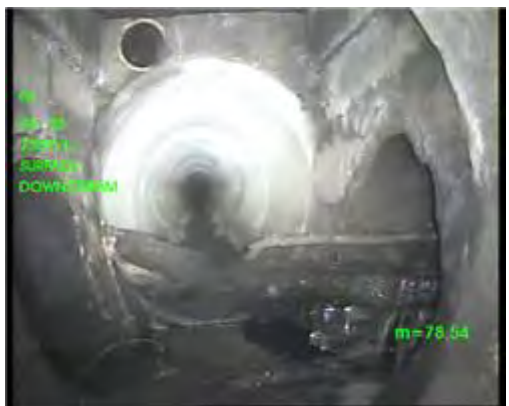
| Pos | Video Ref | Code | Description | Image |
|---|---|---|---|---|
| 78.54m | 0:03:48 | REM | General remark DEBRIS IN MANHOLE | <p>Image Provided - Ref: 9_4</p> |

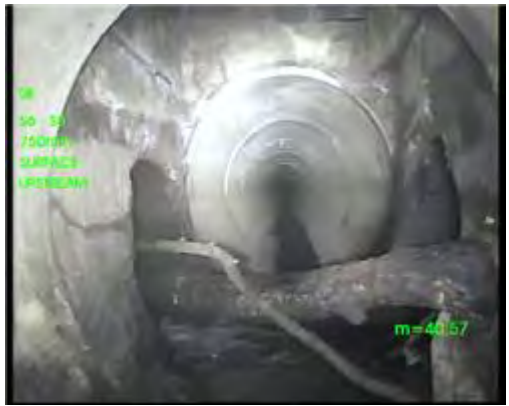
| Pos | Video Ref | Code | Description | Image |
|---|---|---|--|---|
| 40.57m | 0:02:03 | REM | General remark<br>DEBRIS IN MANHOLE | <p>Image Provided - Ref: 10_3</p> |

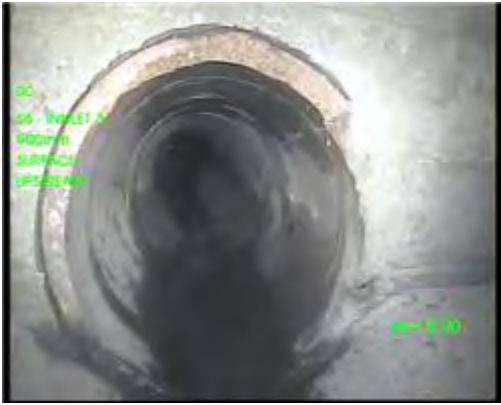
| Pos | Video Ref | Code | Description | Image |
|---|---|---|--|---|
| 00.75m | 0:00:12 | CN | Connection other than junction at 09 o'clock: 300mm Diameter | Image Provided - Ref: 11_2<br> |

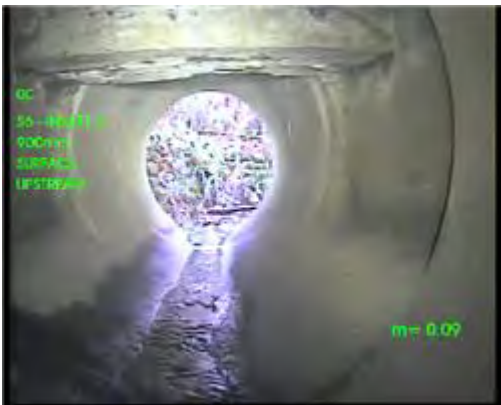
| Pos | Video Ref | Code | Description | Image |
|---|---|---|--|---|
| 00.75m | 0:00:07 | REM | General remark OBSTRUCTION AT HIGH LEVEL / POSSIBLE CHAMBER CONSTRUCTION | Image Provided - Ref: 11_3<br> |

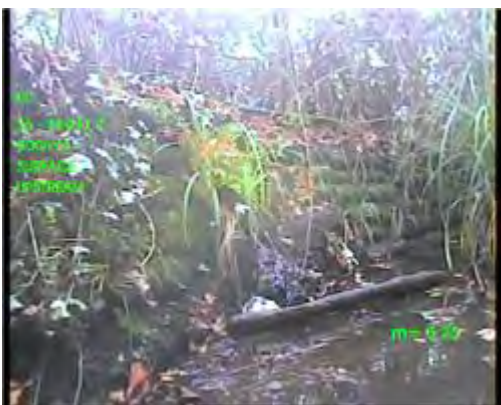
| Pos | Video Ref | Code | Description | Image |
|---|---|---|--|---|
| 03.25m | | WRF | Finish node type, major connection without manhole INLET 3 | Image Provided - Ref: 11_9999<br> |

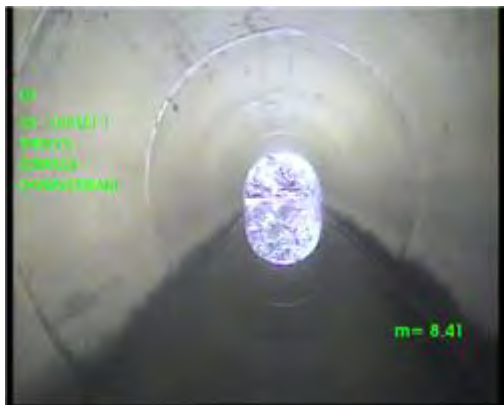
| Pos | Video Ref | Code | Description | Image |
|---|---|---|---|--|
| 08.00m | 0:00:26 | WL | Water level: 20% Height/Diameter | <p>Image Provided - Ref: 12_3</p> |

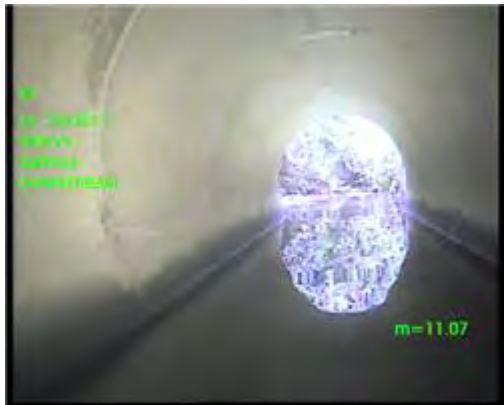
| Pos | Video Ref | Code | Description | Image |
|---|---|---|---|--|
| 11.00m | 0:00:34 | WL | Water level: 30% Height/Diameter | <p>Image Provided - Ref: 12_4</p> |
