# **Outline Veteran Tree Strategy**

**Officers' Meadows**

**Shenfield**

**September 2023**

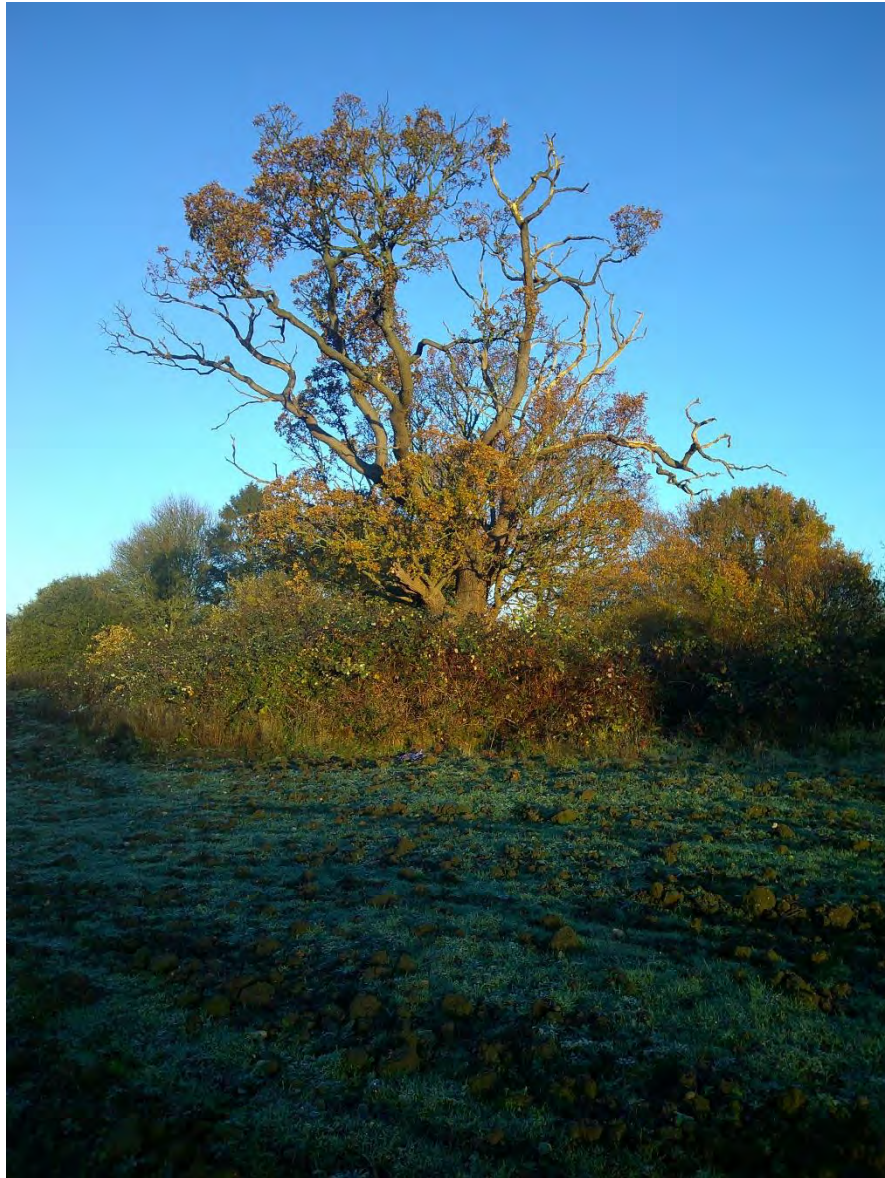
***Photograph 1: view of the tree from the south-east***

3.2.2. The veteran tree has a trunk diameter of 1320mm and is 14m tall. The canopy is 'maiden' with an irregular canopy shape as a result of canopy retrenchment and loss of large diameter lateral branches (maximum crown spread of 11.5m to the south).

3.2.6. This tree, as can be seen in **Photograph 1** above, appears to have had previously developed a broad spreading crown but much of its upper canopy is dying back or is dead. However, the presence of the healthy growth in the tree's inner canopy demonstrates the presence of newer and more vigorous hydrostatic pathways. It can be expected that the outer canopy will continue to decline but that the inner canopy will continue to develop a second canopy and this will probably result in a hollow trunk; thus epitomising 'retrenchment'. In time, this tree has the potential to become a truly ancient specimen.
