# **Outline Veteran Tree Strategy**

**Officers' Meadows**

**Shenfield**

**September 2023**

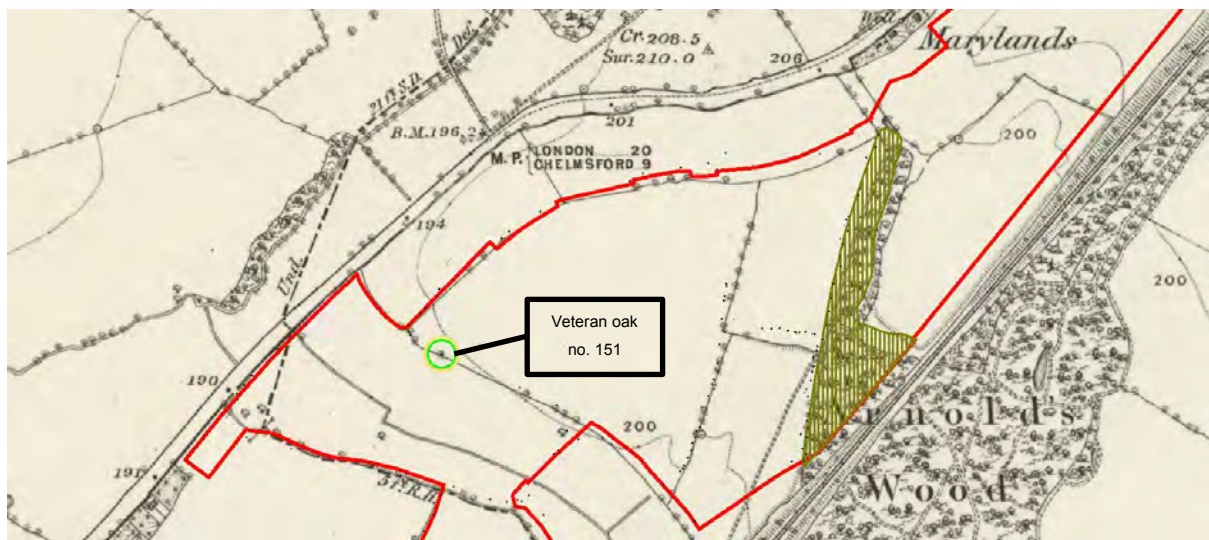
3.1.1. The Ordnance Survey map of 1871 to 1873 (see **Figure 2** below) shows the existing redline boundary, ancient woodland area and the veteran oak overlaid onto the OS plan. The existing location of the veteran oak appears to correspond with an individual tree in the OS plan, which demonstrates that the specimen was old enough to have been in existence at that time.

**Figure 2: Ordnance survey map of 1871 to 1873 published 1881 showing location of veteran oak no. 151 and the ancient woodland in the east section of the site**
