## 071349 Officers Meadow Chelmsford Road Shenfield - CCTV Survey Report : 23/11/20

Name : OFFICERS MEADOW  
 Contact :  
 Location : CHELMSFORD ROAD  
 Town : SHENFIELD  
 Region : ESSEX  
 Postcode :  
 Tel :  
 Mobile :  
 Email :  
 Fax :

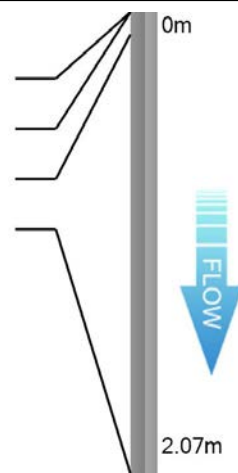
| Position | Code | Description | CD | Pic | Video Ref |
|---|---|---|---|---|---|
| 00.10m | JDM | Joint displaced medium | | | 0:00:05 |

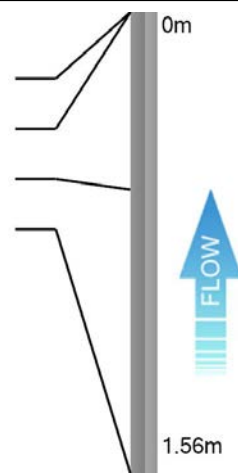
| Position | Code | Description | CD | Pic | Video Ref |
|---|---|---|---|---|---|
| 00.60m | DER | Settled deposits coarse 20% | | | 0:00:06 |

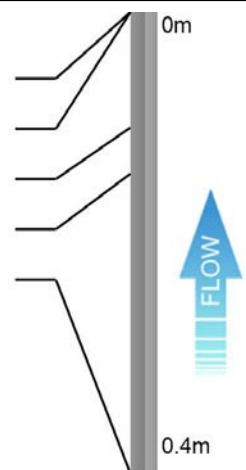
| Position | Code | Description | CD | Pic | Video Ref | |
|---|---|---|---|---|---|--|
| 00.14m | DER | Settled deposits coarse 30% | | 7_2 | 0:00:05 | |
| 00.40m | SA | Survey abandoned | | | | |

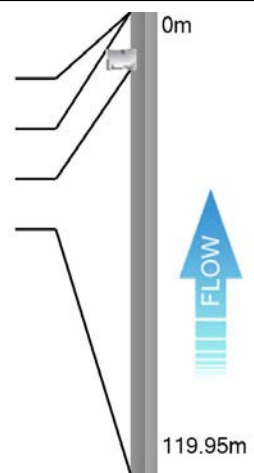
| Position | Code | Description | CD | Pic | Video Ref | |
|---|---|---|---|---|---|--|
| 15.00m | CXI | Connection intruding 01 10% : 150mm Diameter | | | 0:00:48 | |
