# CCTV REPORT

| <b>DATE</b> | 23/11/2020 |

Site  
**OFFICERS MEADOW  
CHELMSFORD ROAD  
SHENFIELD  
ESSEX**

## 071349 Officers Meadow Chelmsford Road Shenfield - CCTV Survey Report : 23/11/20

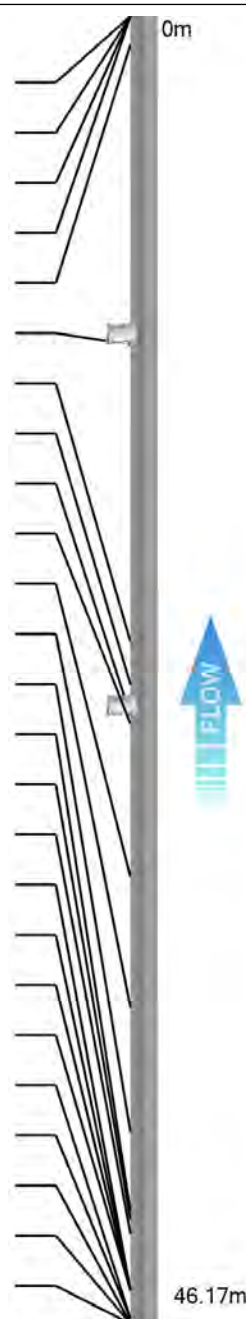
| Position | Code | Description | CD | Pic | Video Ref | |
|---|---|---|---|---|---|---|
| 45.00m | FL | S2 Fracture longitudinal 03 | S2 | | 0:05:21 | |
| 45.00m | FL | S3 Fracture longitudinal 09 | S3 | | 0:05:21 | |
| 45.00m | FL | S4 Fracture longitudinal 12 | S4 | | 0:05:21 | |
| 46.17m | FL | F4 Fracture longitudinal 12 | F4 | | 0:05:21 | |
| 46.17m | FL | F3 Fracture longitudinal 09 | F3 | | 0:05:21 | |
| 46.17m | FL | F2 Fracture longitudinal 03 | F2 | | 0:05:21 | 46.17m |

| Position | Code | Description | CD | Pic | Video Ref | |
|---|---|---|---|---|---|---|
| 46.17m | B | Broken pipe 12-12 | | | 0:05:53 | |

| Pos | Video Ref | Code | Description | Image |
|---|---|---|---|---|
| 46.17m | 0:05:53 | B | Broken pipe from 12 o'clock to 12 o'clock - Severity 4 | |
| 46.17m | | SA | Survey abandoned<br>BROKEN PIPE | |

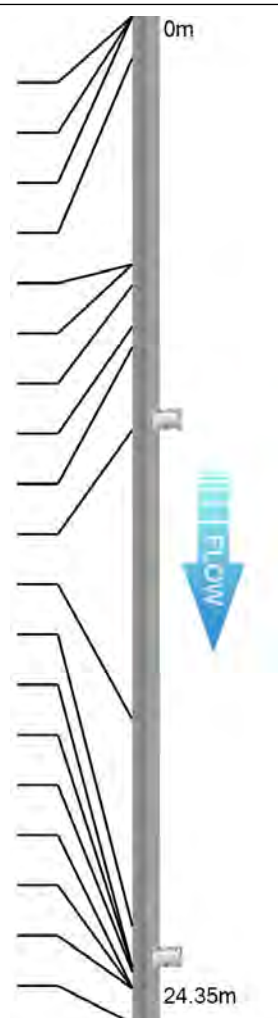
| Position | Code | Description | CD | Pic | Video Ref | |
|---|---|---|---|---|---|---|
| 23.50m | DEE | Attached deposits, encrustation 07-05 30% | | 1_15 | 0:03:05 | |
| 24.35m | SA | Survey abandoned | | | | 24.35m |

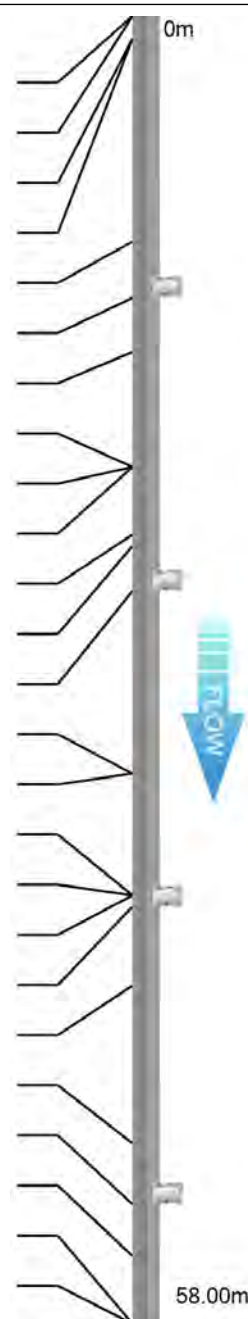
| Position | Code | Description | CD | Pic | Video Ref | |
|---|---|--|---|---|---|--|
| 33.60m | CLJ | Crack, longitudinal 03 at joint | | | 0:04:24 | |
| 33.60m | CLJ | Crack, longitudinal 12 at joint | | | 0:04:24 | |
| 39.00m | FL | S3 Fracture longitudinal 12 | S3 | | 0:05:09 | |
| 39.00m | FL | S4 Fracture longitudinal 09 | S4 | | 0:05:09 | |
| 43.00m | FL | S5 Fracture longitudinal 03 | S5 | | 0:05:58 | |
| 58.00m | FL | F5 Fracture longitudinal 03 | F5 | | 0:05:58 | |
| 58.00m | FL | F4 Fracture longitudinal 09 | F4 | | 0:05:09 | |

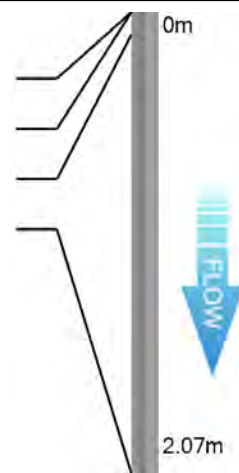
| Position | Code | Description | CD | Pic | Video Ref |
|---|---|---|---|---|---|
| 00.10m | JDM | Joint displaced medium | | | 0:00:05 |

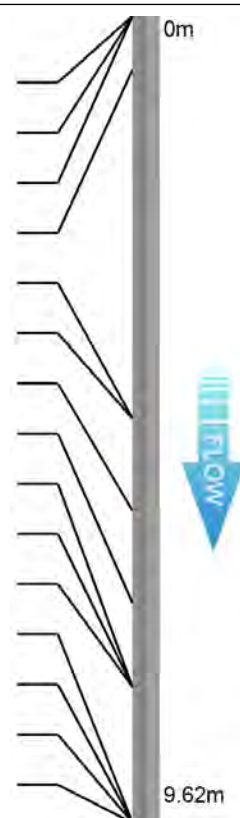
| Position | Code | Description | CD | Pic | Video Ref | |
|---|---|---|---|---|---|--|
| 09.62m | CM | F3 Cracks, multiple 08-04 | F3 | | 0:00:44 | |
| 09.62m | SA | Survey abandoned | | | | |

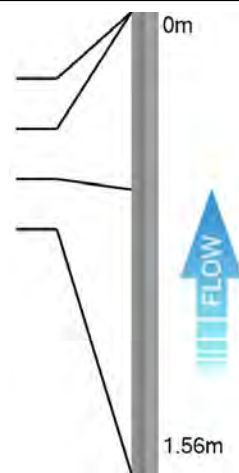
| Position | Code | Description | CD | Pic | Video Ref |
|---|---|--|---|---|---|
| 00.60m | DER | Settled deposits coarse 20% | | | 0:00:06 |

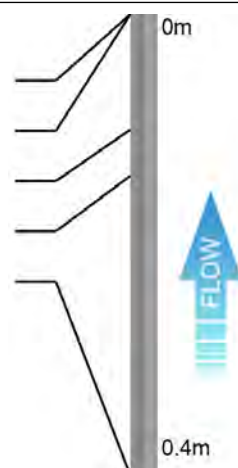
| Position | Code | Description | CD | Pic | Video Ref | |
|---|---|---|---|---|---|--|
| 00.14m | DER | Settled deposits coarse 30% | | 7_2 | 0:00:05 | |
| 00.40m | SA | Survey abandoned | | | | |

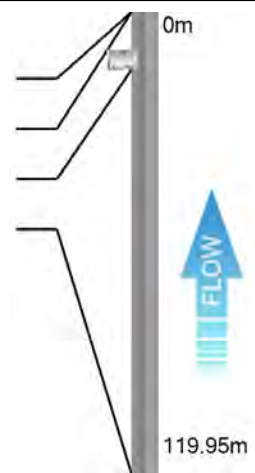
| Position | Code | Description | CD | Pic | Video Ref | |
|---|---|--|---|---|---|--|
| 15.00m | CXI | Connection intruding 01 10% : 150mm Diameter | | | 0:00:48 | |

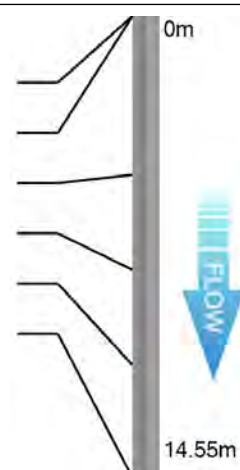
| Position | Code | Description | CD | Pic | Video Ref | |
|---|---|---|---|---|---|--|
| 11.00m | WL | Water level 30% | | 12_4 | 0:00:34 | |
